HabaCHAIN®

Multi-Hub 881 Sprocket-Rims

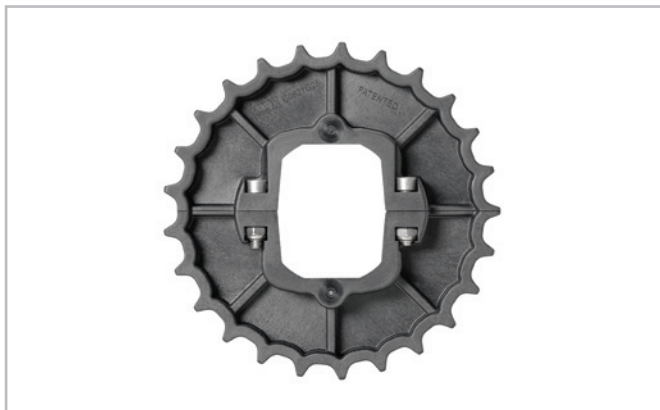
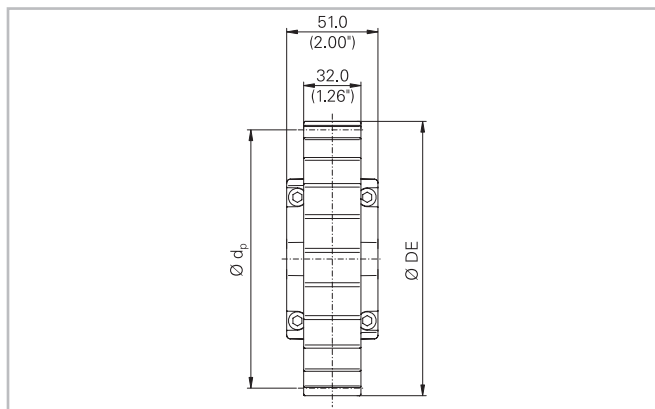
Multi-Hub 881 Sprocket-Rim is suitable for 881 series chains. Two Multi-Hub 881 sprockets form a 821 sprocket. The splitted sprocket rim is available also in special noise dampening material. Different bore configurations can be obtained by using separate Multi-Hub inserts. The customized combination of materials and the high fabrication accuracy ensure a high wear resistance, low noise and optimized power transmission.

Habasit code	Number of teeth	Ø DE		Diam. of pitch Ø d _p		Material
		mm	inch	mm	inch	
C0881G25	25	153.8	6.06	153.2	6.03	LI
C0881G25+ND	25	153.8	6.06	153.2	6.03	ND

- Included in delivery: 2 sprocket rim halves, 4 screws, 4 self-locking nuts
- Nuts and screws: stainless steel
- Special noise dampening material available: +ND
